CALIFORNIA DIVISION OF MINES AND GEOLOGY

Fault Evaluation Report FER-32

March 24, 1977

1. Name of fault: Carpenteria fault.
2. Location of fault: Carpenteria and White Ledge Peak quadrangles, Santa Barbara County, California (see figure 1).

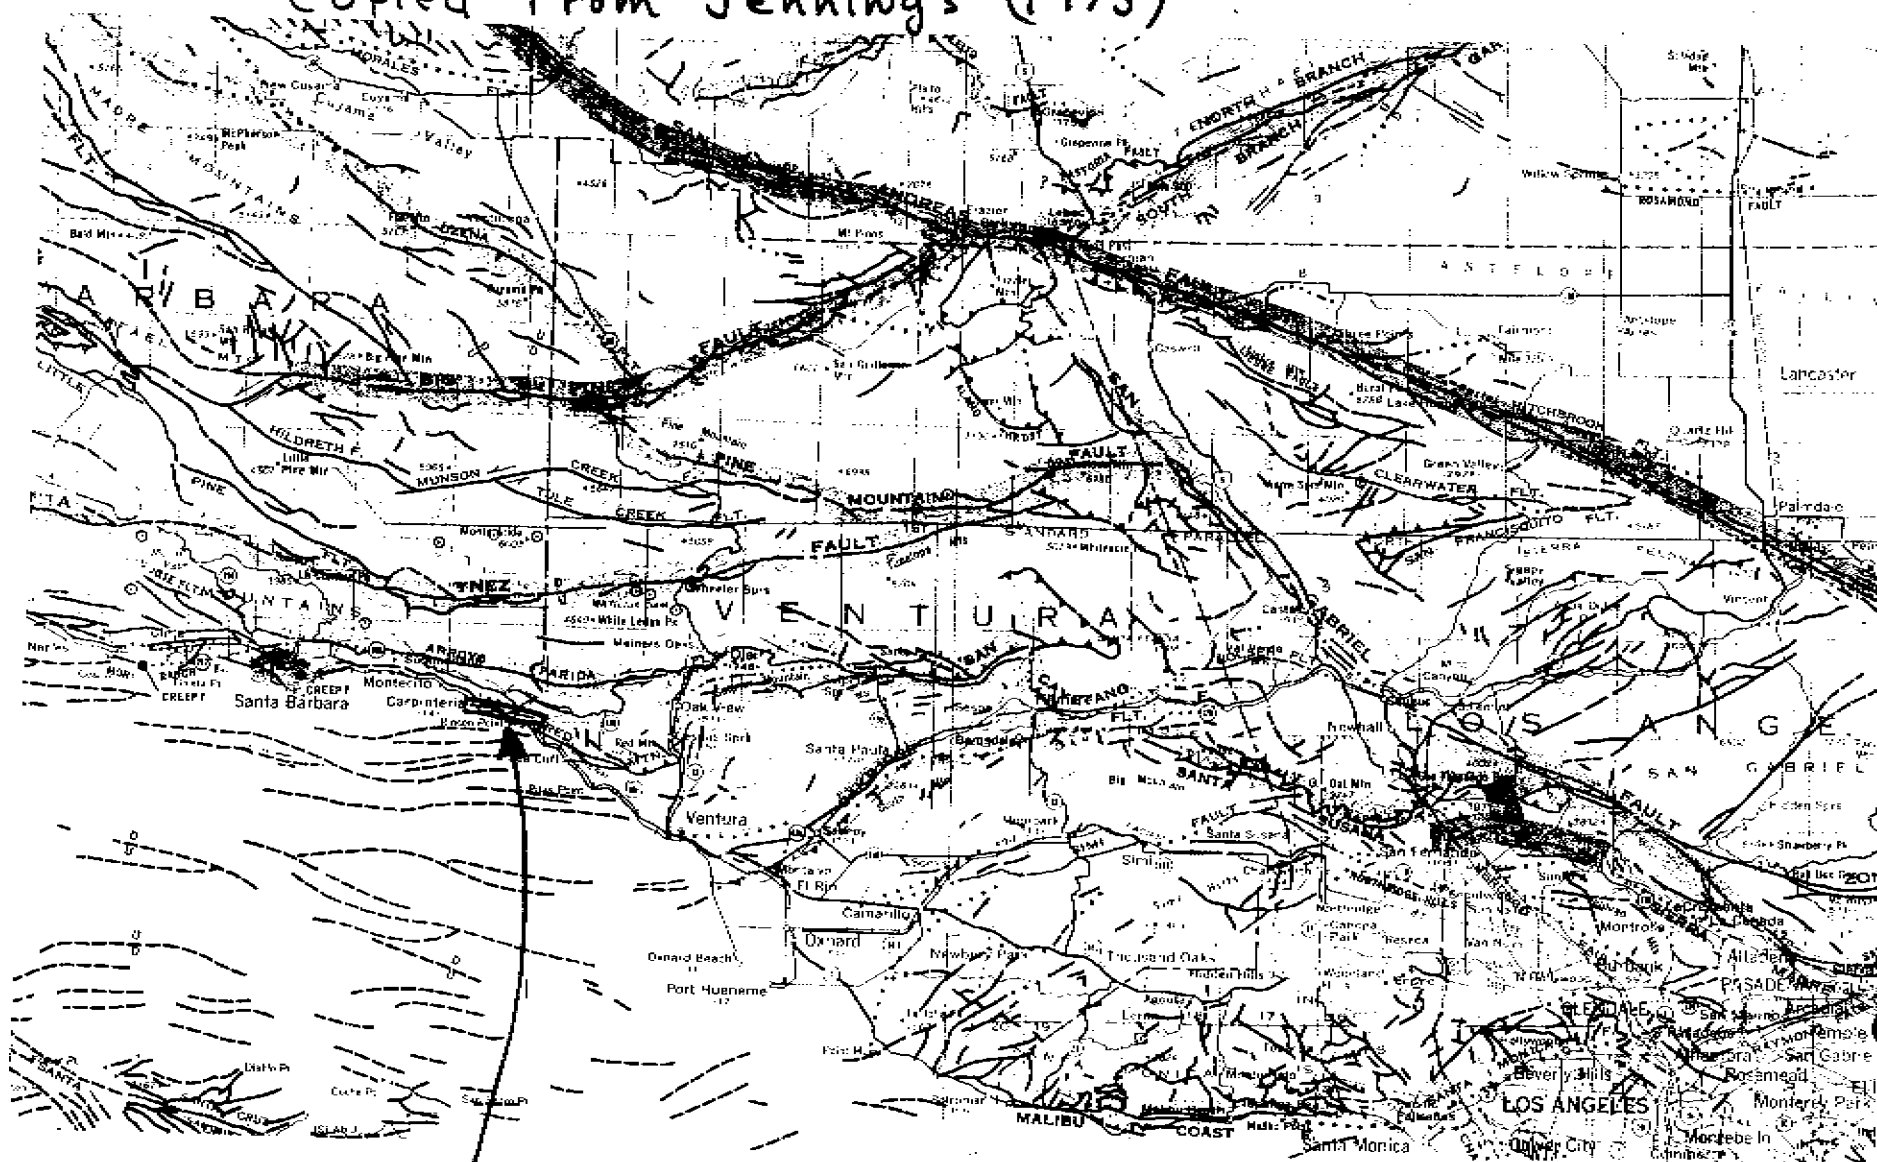
Fig 1

Carpenteria fault

The Carpenteria fault is a four-mile long, east-trending feature (see figure 1) that is shown on small scale maps of Ziony (1974) and Jennings and Troxel (1954). There is some disagreement as to the fault's surface location, based on more detailed maps of Lian (1952) and Upson (1951) (see plate 1 in this report). This disagreement stems from the fact that the Carpenteria fault is actually a fault-zone of some width.

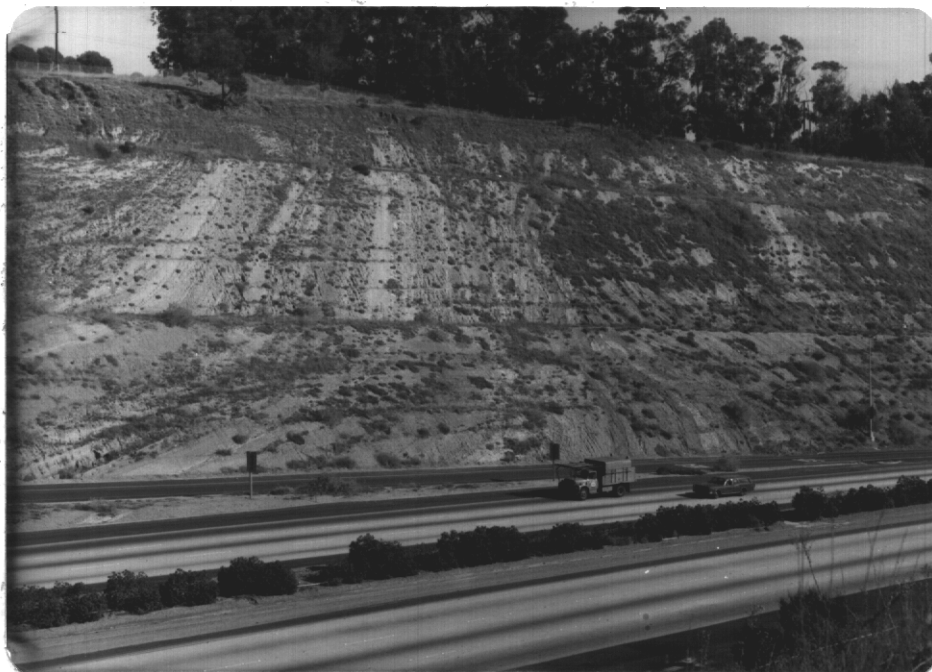
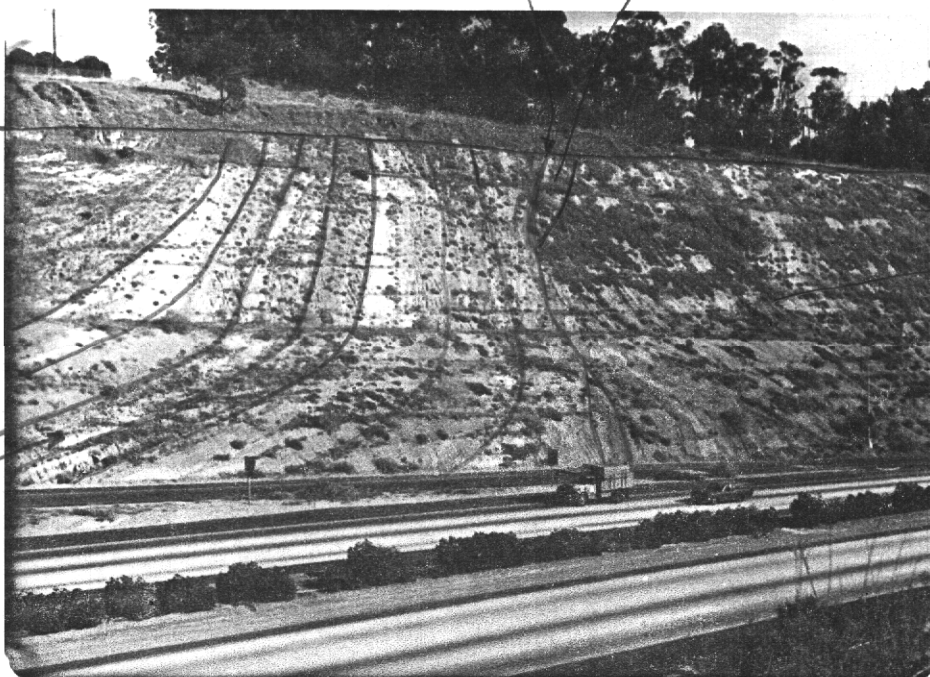
Fig. I

3) See figure 3 with accompanying photo. Carpenteria Formation (middle Pleistocene) is faulted against Monterey Formation (Miocene). The Carpenteria beds have been upturned near the fault and appear to be dragged. This drag indicates the north side of this fault has been down-dropped relative to the south side. As can be seen in figure 3, a younger (late Pleistocene?) terrace deposit overlies these units and the fault and appears to be unfaulted. The strike of the sheared beds near the fault contact with the Carpenteria beds is N. 80° W. Sheared and faulted, steeply-dipping ^{and contorted} Monterey strata are continuously exposed to the south for 500-700' beyond the photo.

View looking east—Monterey Formation on the south faulted against Carpenteria Formation on the north.

Fault $N80^{\circ}W$ - nearly vertical Dip

Sheared Tml beds

Qcp beds
 upturned as
 they near the
 fault.

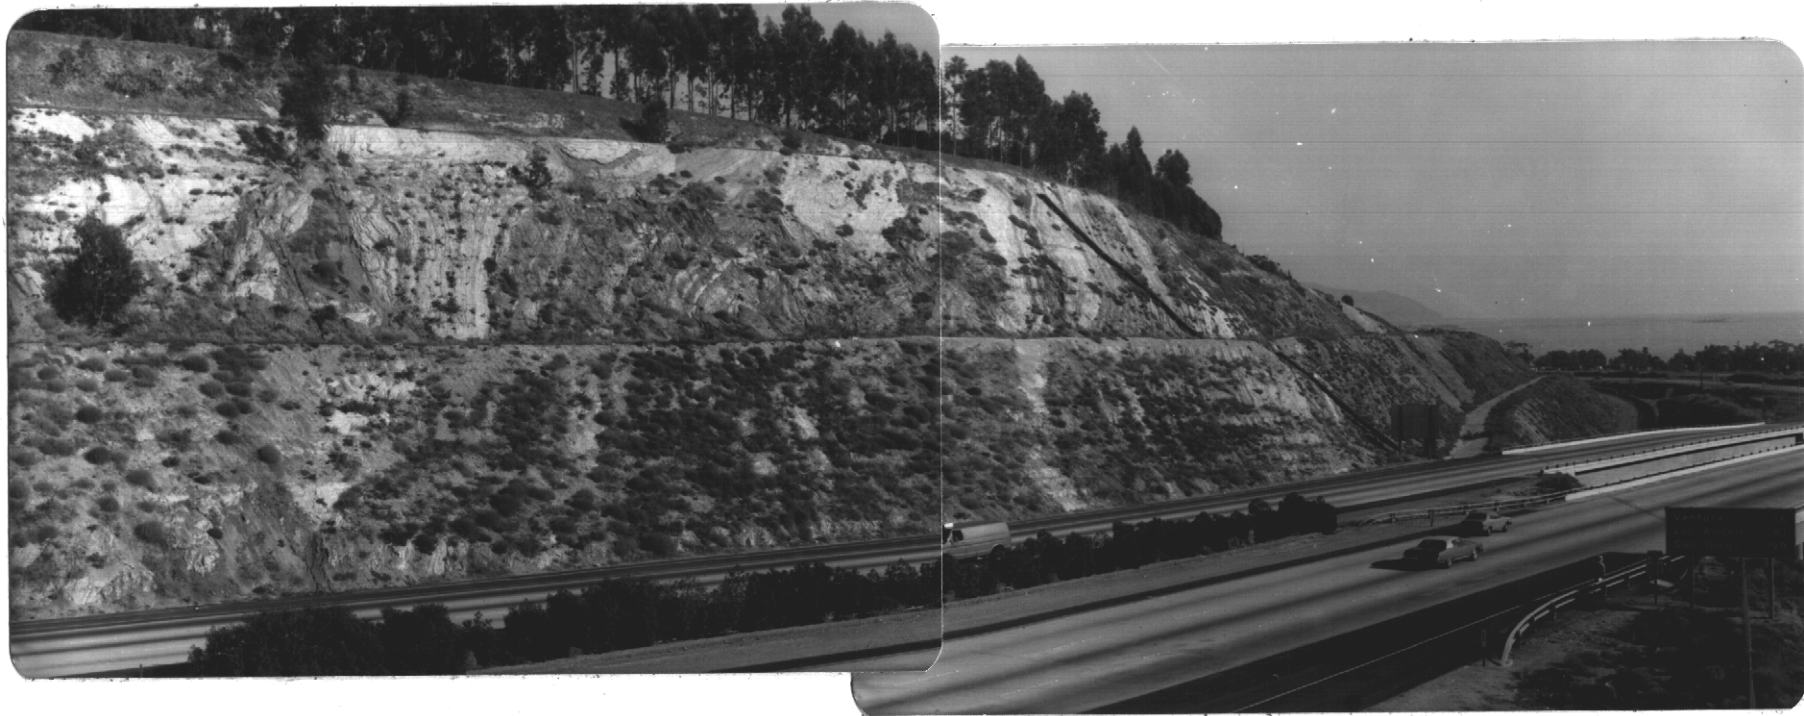
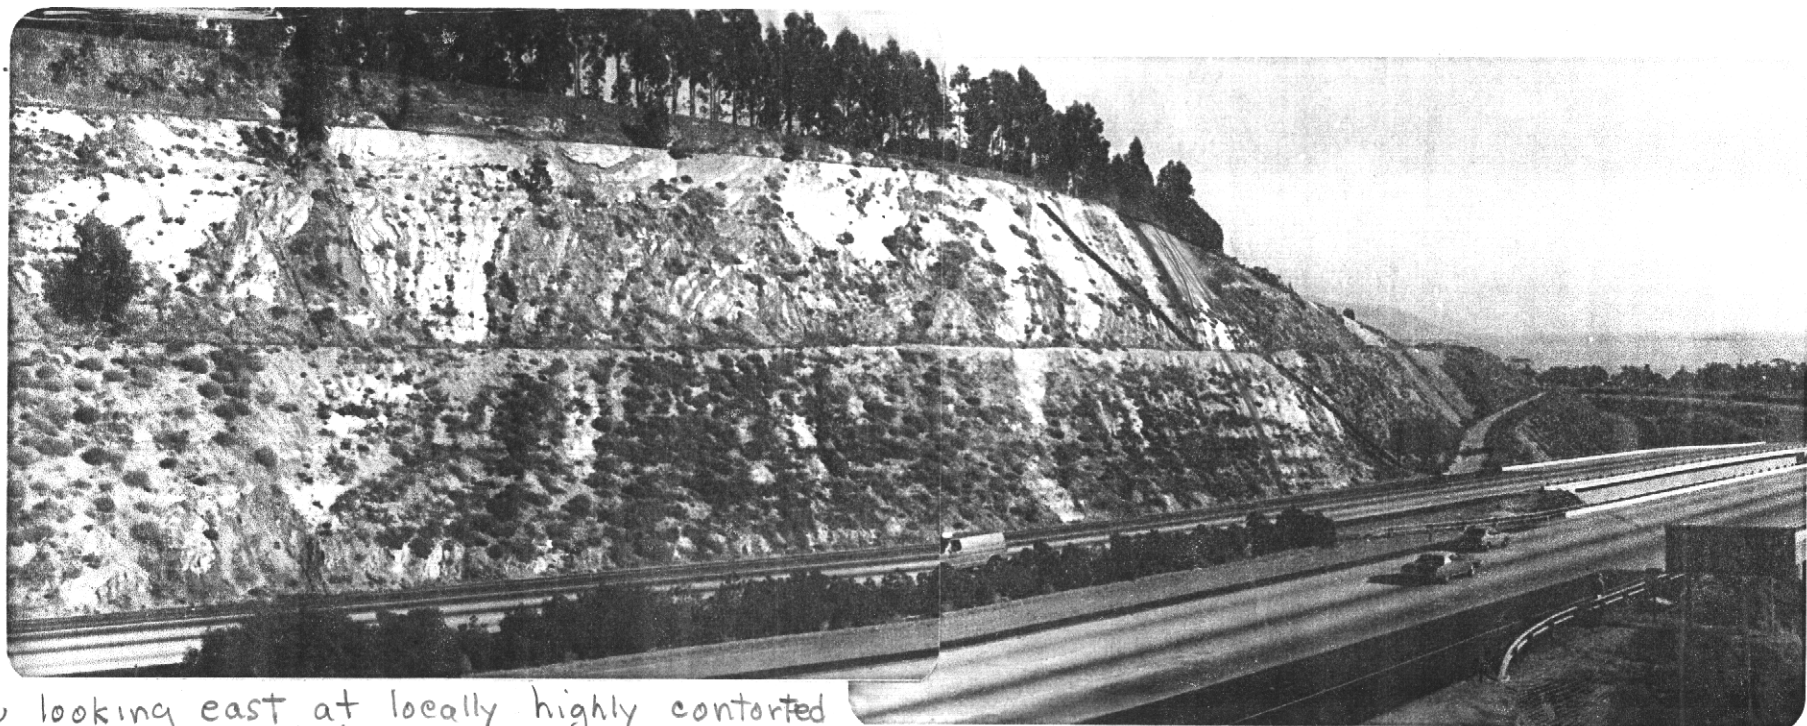
Fig. 4

4) The bracketed area at locality 4 is a continuation of the roadcut described at locality 3. Here, the Monterey beds are sheared, steeply dipping, and locally highly contorted (figure 4). Although the beds are nearly vertical. The age of faulting in this section of rocks is also difficult to determine. Younger terrace materials overlie the Monterey rocks locally here, but not everywhere. However, the lack of a scarp in the upper erosion surface suggests the absence of recent dip-slip fault displacement.

View looking east at locally highly contorted
 Monterey Formation ^{beds.} ~~rocks~~. Red line at south end of roadcut defines the boundary
 between contorted beds ^(left) and vertical beds which are not contorted (see locality 4).

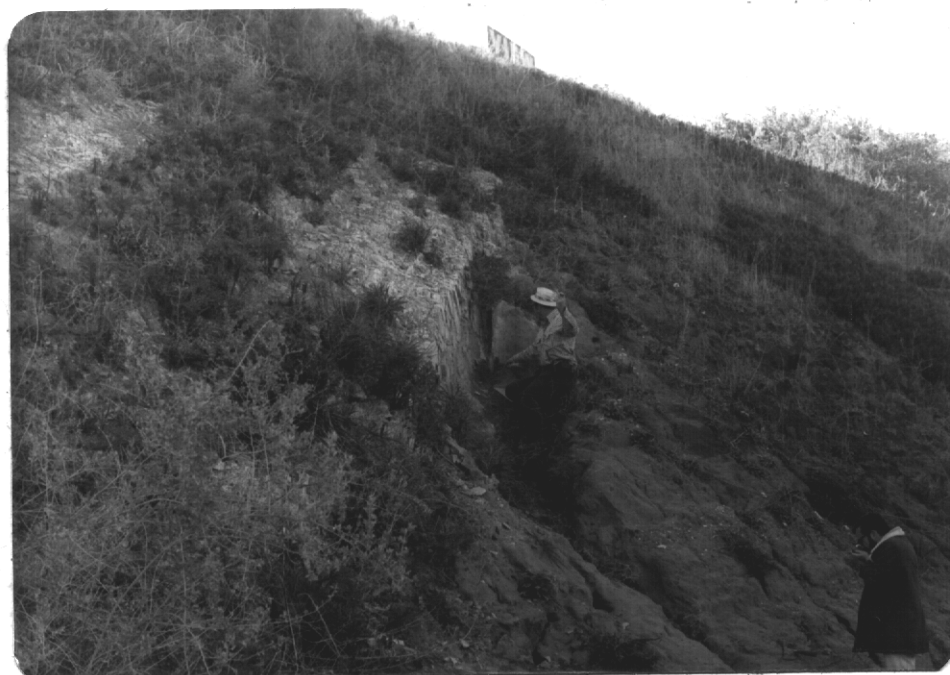
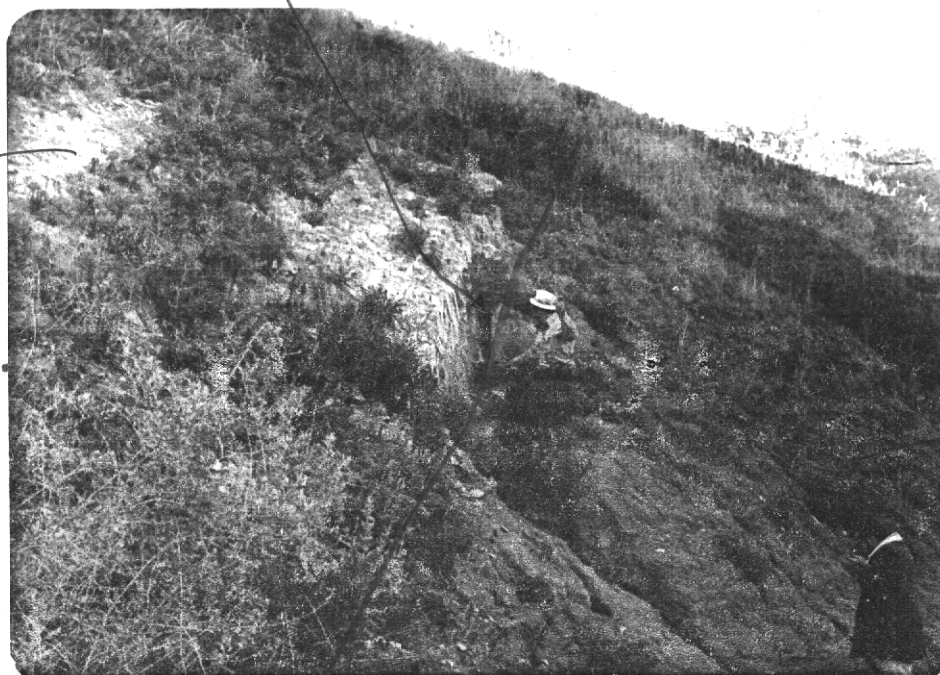
Fig. 5
U.S. 101
Roadcut

5) See figure 5 with accompanying photo. This locality, on the west side of U.S. Highway 101, shows Monterey Formation on the south in fault contact with a sandy terrace material. At the contact a three inch wide gouge zone can be seen. The gouge zone is nearly vertical and the Monterey rocks have the same attitude as the gouge (N. 65° W. strike).

View looking west — Monterey Formation on the south faulted against Quaternary terrace deposits on north.

3" fault gouge

Fault N65 W
Vertical dip

This fault strikes in the direction of the contorted Monterey rocks to the southeast, but no discrete fault on the east side of the highway could be matched with it. ~~although~~² the fault identified at locality 3 appears to lie about 100' north of this fault. ^{Al}though it can not be seen in the photo in figure 5, an approximately five-foot thick terrace sand overlies these units and appears to be unfaulted.
